FOURTH ENDORSEMENT on VF-121 AAR ser 6-58 concerning TV-2 BUNO 136834
accident occurring 22 September 1958, pilot [REDACTED] (b) (6)

THIRD ENDORSEMENT on VF-121 AAR ser 6-58 concerning TV-2 BUNO 136834
accident occurring 22 September 1958, pilot (b) (6)

SECOND ENDORSEMENT on VF-121 AAR Serial 6-58 concerning TV-2, BuNo
136834, accident occurring 22 September 1958, Pilot (b) (6)

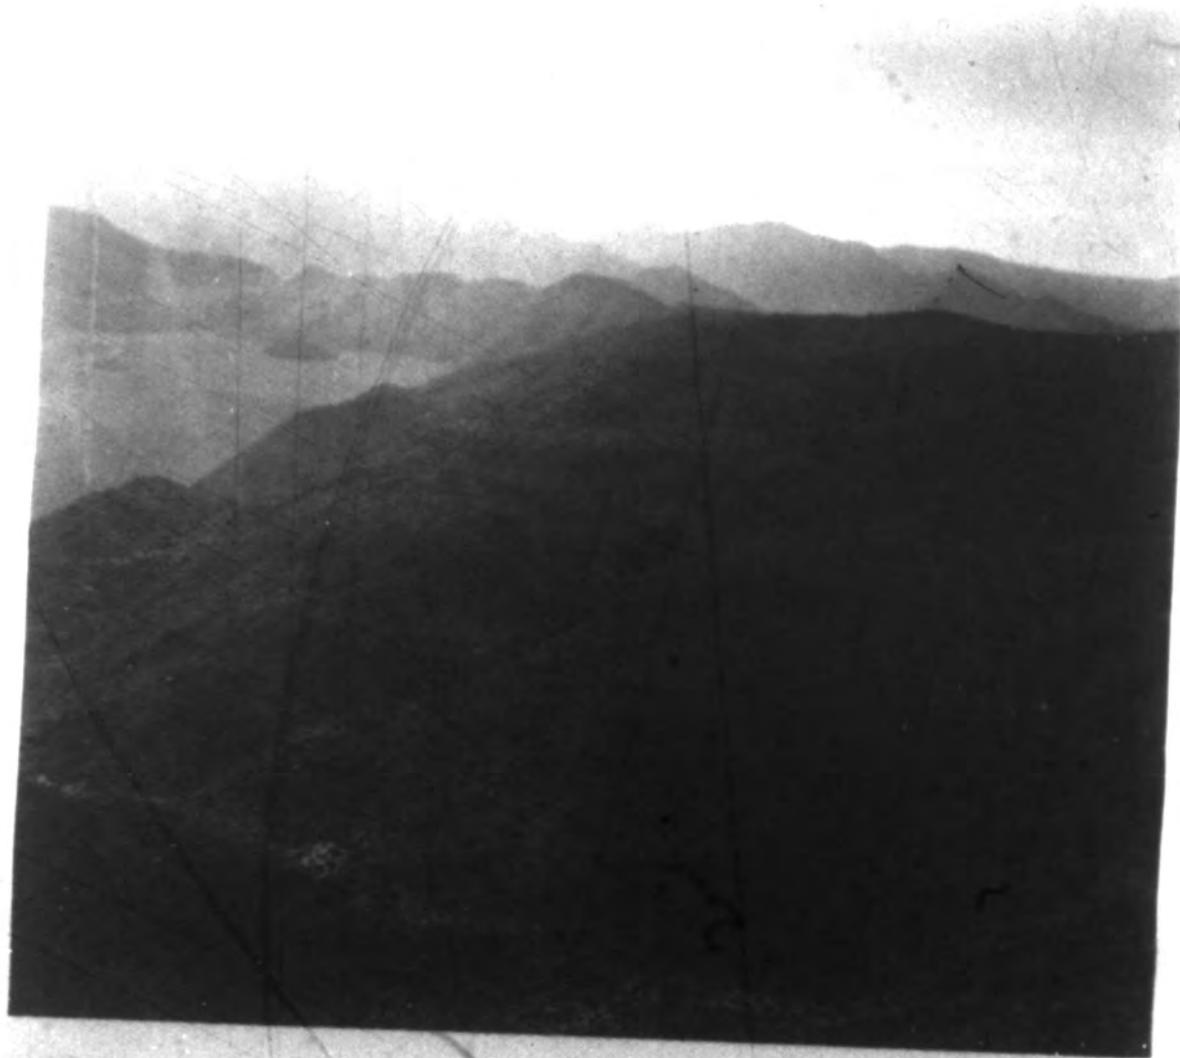
ENCLOSURE 4A VF-121 AAR 6-58

POINT OF IMPACT. Heading of Aircraft upon impact, approximately 240°.

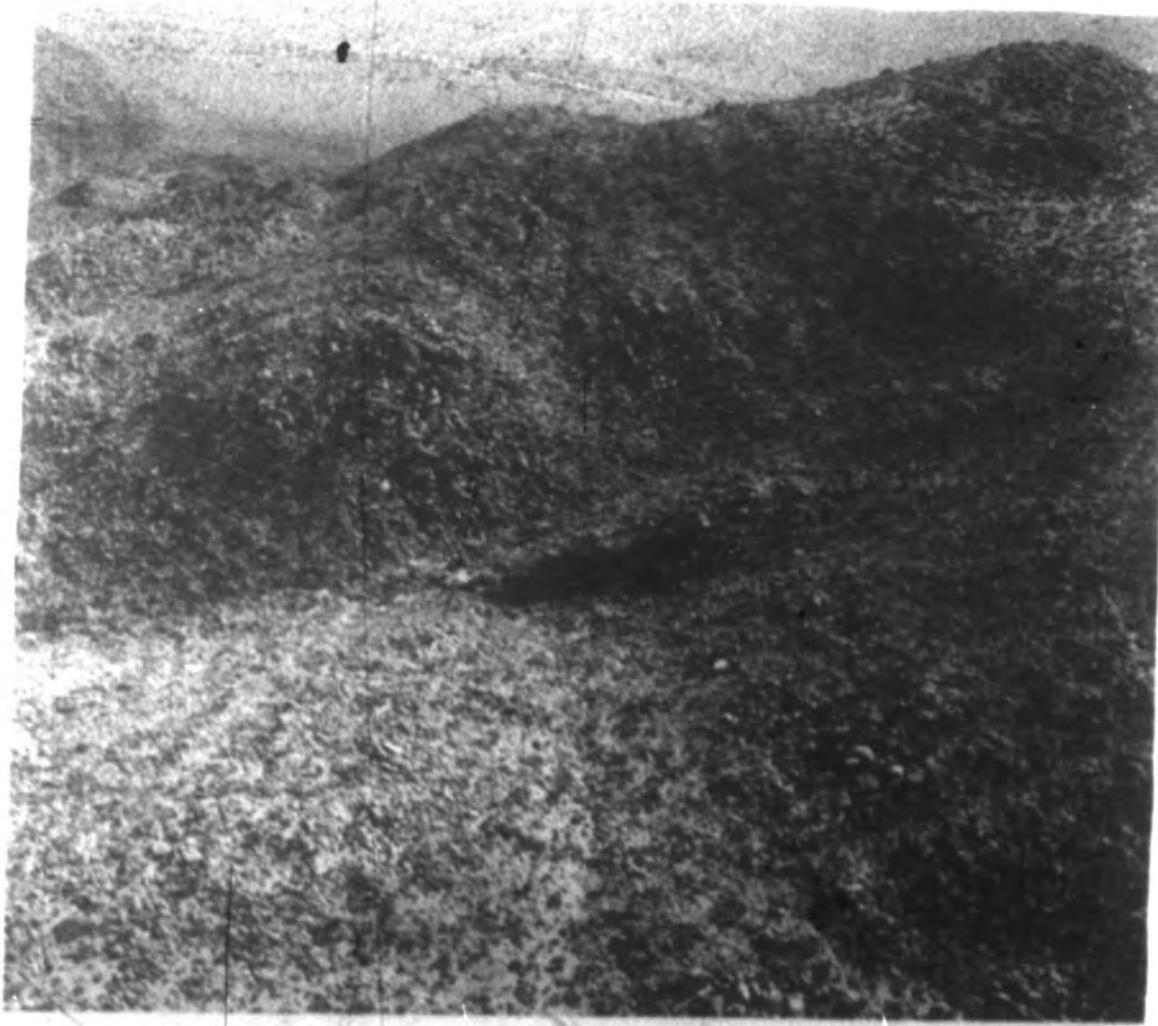
ENCLOSURE 4B VP-121 AAR 6-58

CLOSE UP AERIAL PHOTO OF CRASH SCENE. Initial impact to the left of
burned area. Fire result of impact.

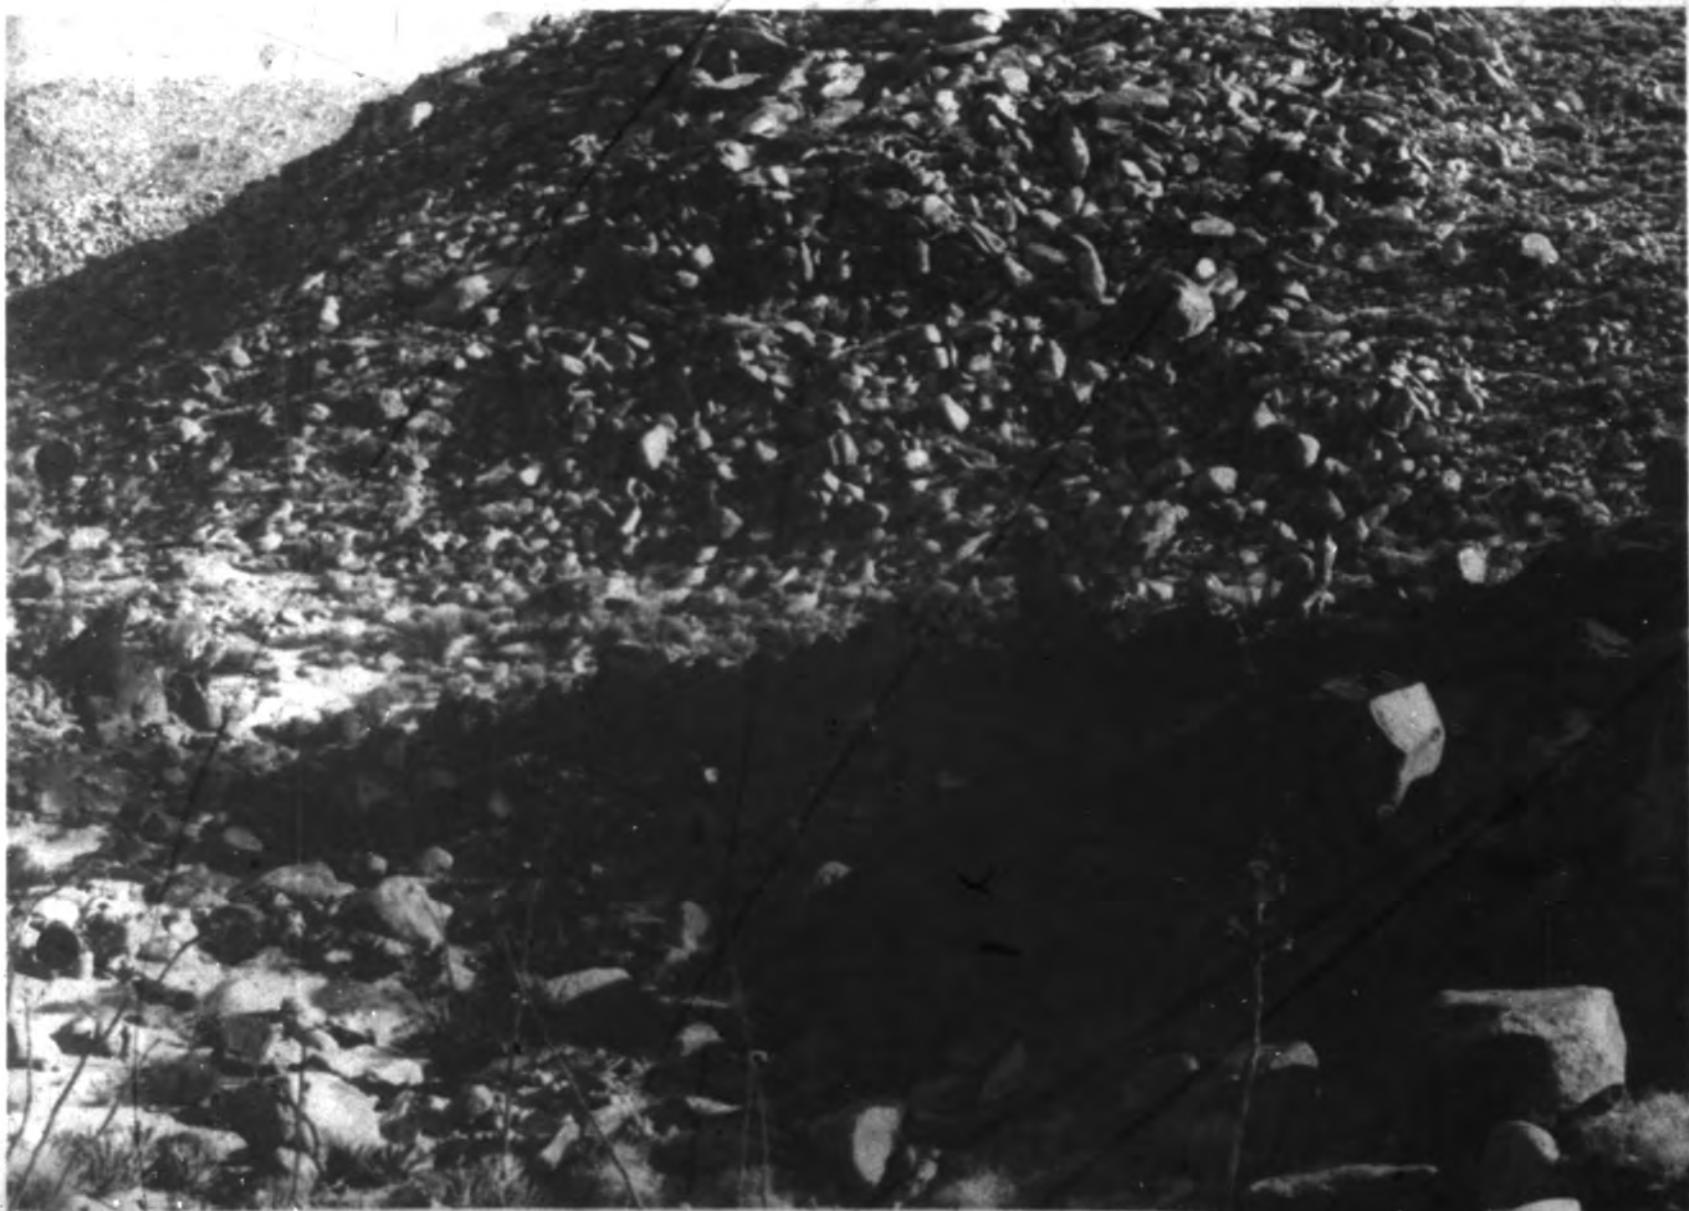
ENCLOSURE 1C VF-121 AAR 6-58

- IMPACT AREA OF CRASH. Note initial impact to the left, empennage and final position right center, clamshell nose section door in foreground.

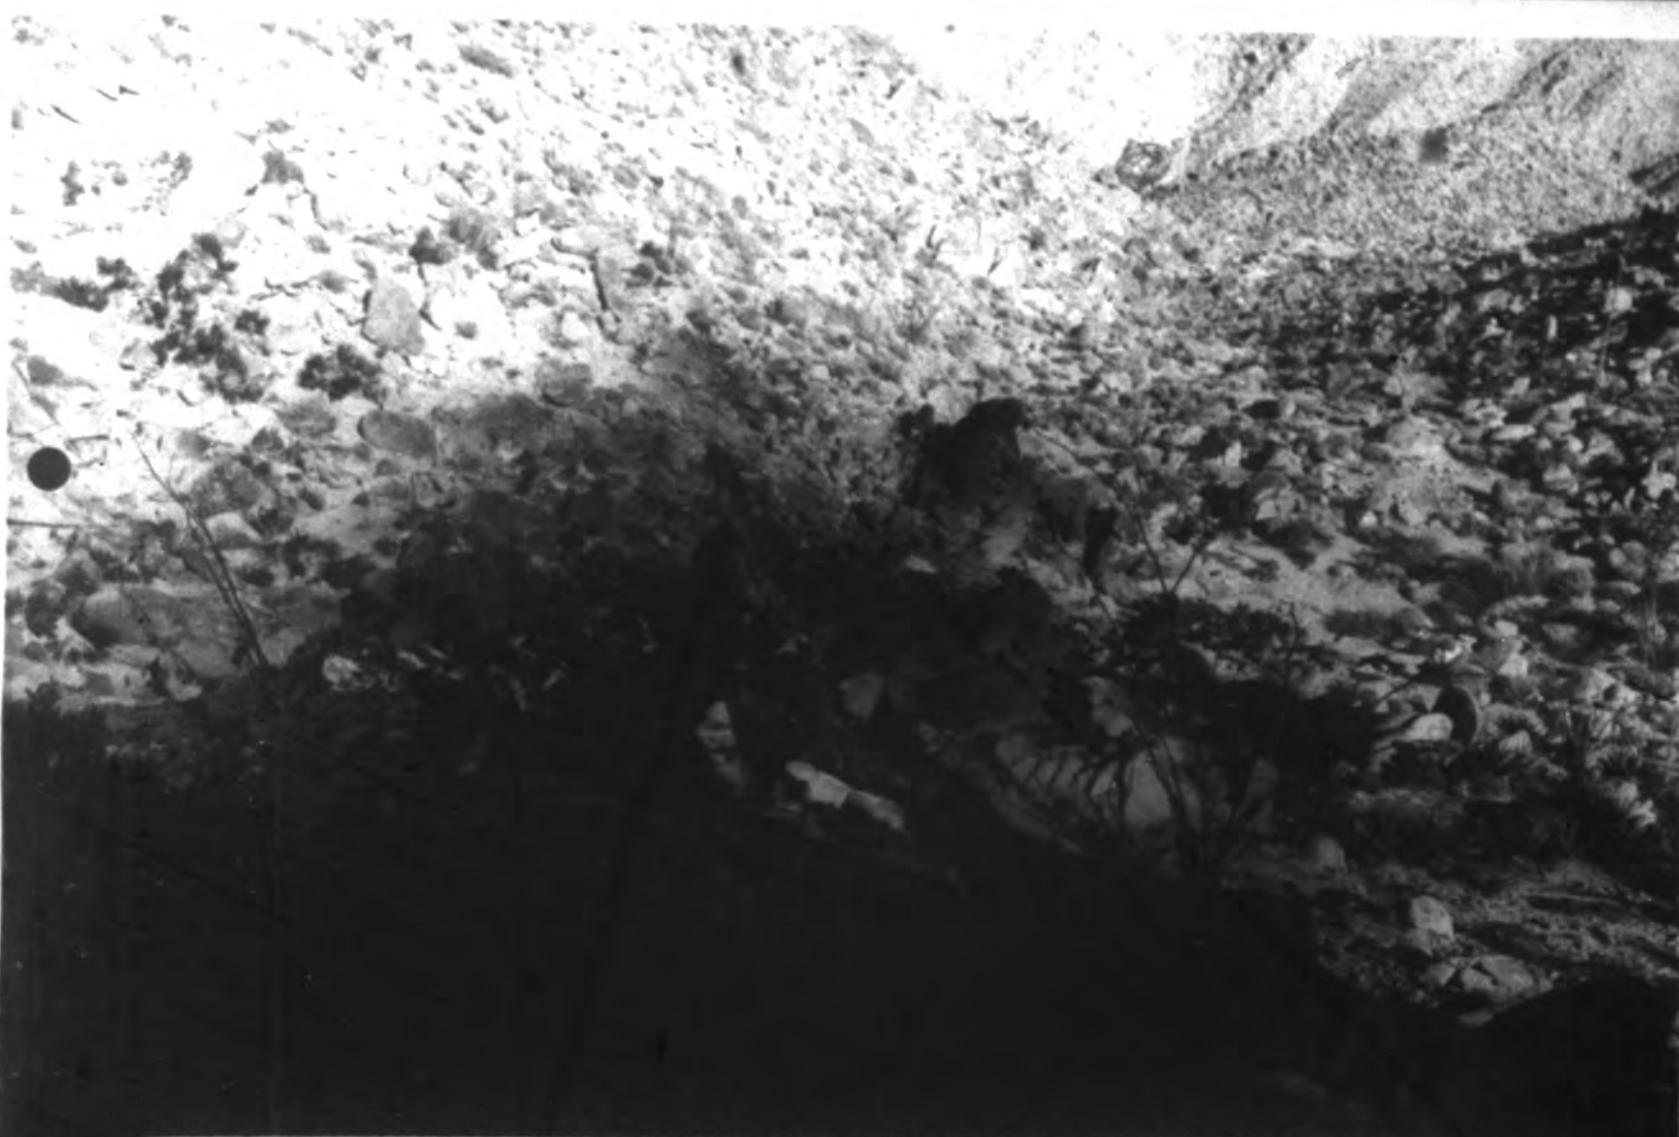
ENCLOSURE 4D VF-121 AAR 6-58

On the first impact with the ground the left wing tip and tank tore away starting a fire which eventually consumed the entire aircraft. The next impact was approximately 150 feet, 240° from initial impact when the aircraft apparently exploded, with bits of the instrument panels, engine accessories, main landing gear bits and pieces strewn over a circle of 250 feet in diameter. The wreckage bounced another 150 feet before the remains of the tail and engine reached their final resting place. Bits and pieces of the nose section, AN/ARC-27, wing fuel filler caps, gun access doors, etc., were found approximately 500 feet from the point of initial impact.

INDICATES LINE OF FLIGHT. Note initial point of impact directly behind
wreckage left tip tank torn off at this point.
